tunnels & tunnelling INTERNATIONAL

Lausanne's M2 subway stays on track

F Gaj and M Badoux, of Metro Lausanne – Ouchy SA, describe the construction of Lausanne's new subway line and in particular the collapse and recovery of the Saint Laurent Tunnel in 2005

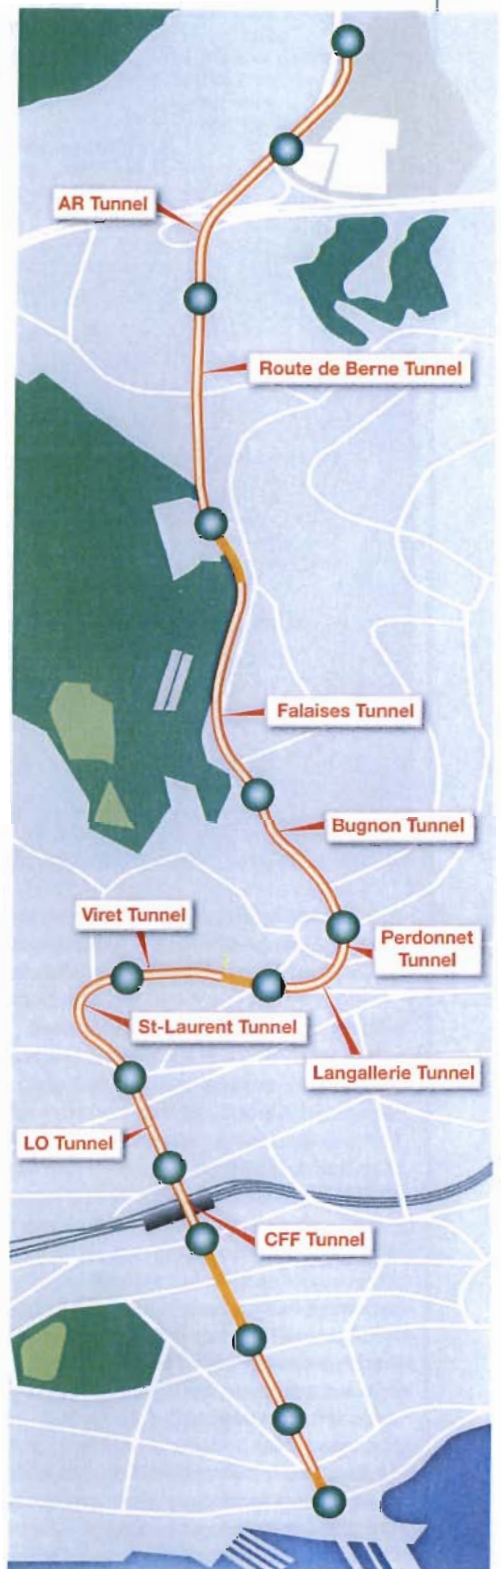
Above: Excavating the Langallerie tunnel
Right: Fig 1 - M2 alignment with tunnels

The M2 tunnels have been excavated by Eickhoff and Voest-Alpine roadheaders (*T&T* November 2004) in full sections varying from 9.9m wide x 6.7m high to 11.7m wide x 7.6m high, except for the Langallerie tunnel which was excavated sequentially, starting with side drifts, top heading, bench and invert.

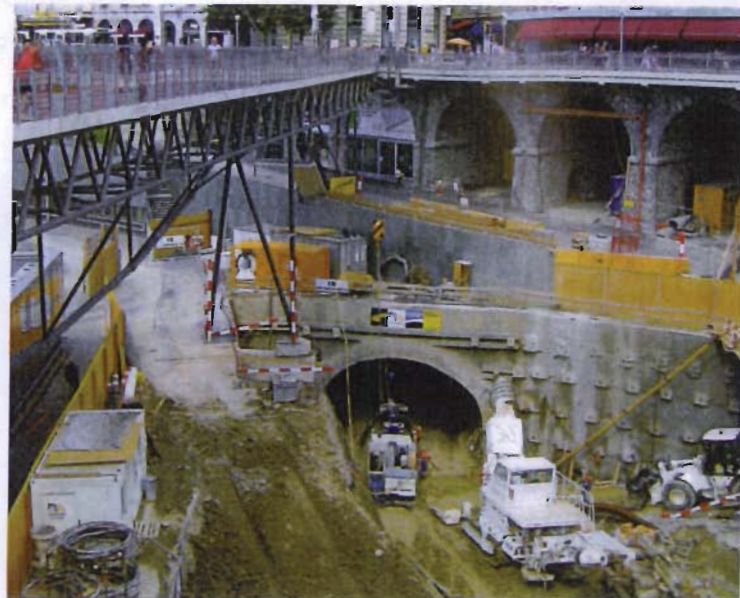
Top: Saint-Laurent tunnel. Note the passage under the 19th Century 'Grand-Pont' masonry bridge
Above: Construction of the Pont St-Martin below the Pont Bessières

- The Saint-Laurent tunnel, where excavation took place beneath an old

masonry bridge called the Grand-Pont

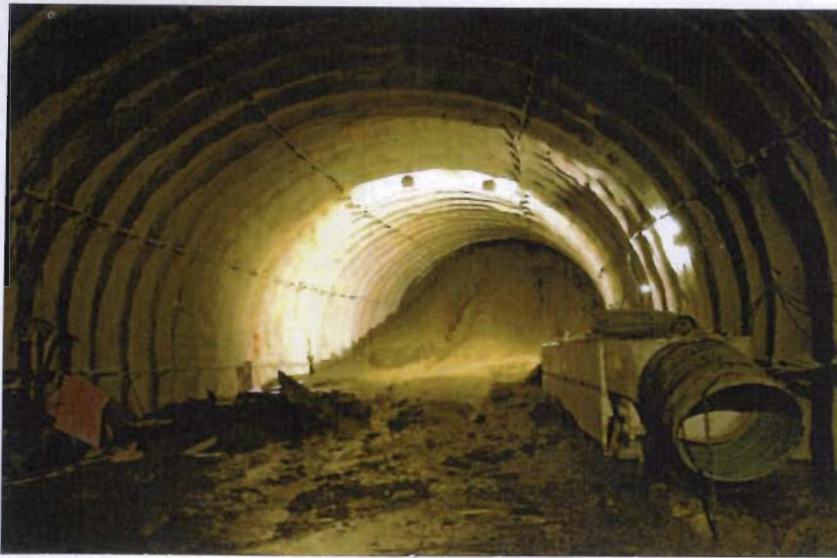
Left: View inside the collapsed Saint-Laurent tunnel

The project was unfortunately marred by a serious construction accident late in the afternoon on 22 February 2005, when the face of the Saint-Laurent tunnel collapsed after an unexpected pocket of saturated sands and gravels was encountered.

The collapse was sudden and came after water infiltration went from minor to significant within two hours. A large volume of mud flowed into the tunnel. As a result, a sinkhole formed under a main square of Lausanne's downtown historic shopping district (Place St-Laurent) and partially under the foundations of a multi-story building. In the following hours, the sinkhole volume grew to about 1500m³.

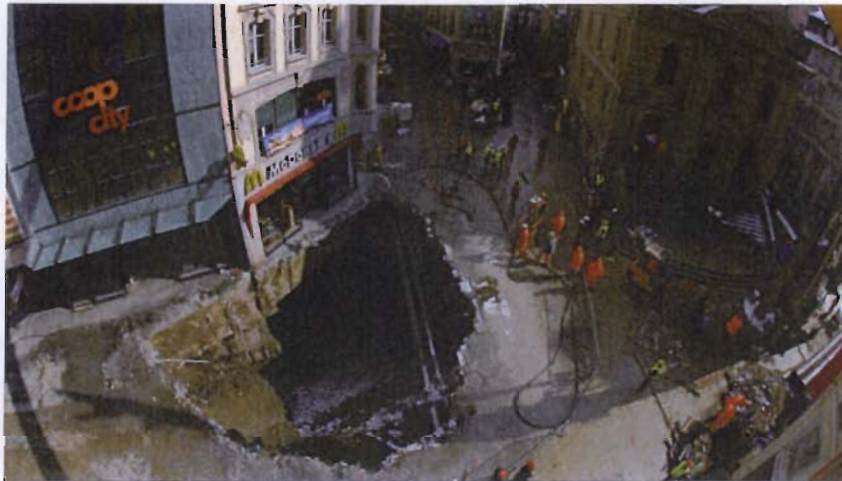
Below: View of the historical Place Saint-Laurent after the accident

- Stabilisation of the sinkhole walls with shotcrete
- Further stabilisation of the sinkhole with sprayed liquid nitrogen, to freeze the soil and reduce the erosion induced by water
- Creation of a wall of piles bored from the surface into the tunnel. This wall acted as a 'plug' by blocking the flow of material from the sinkhole into the tunnel
- Filling of the tunnel 'upstream' of the plug wall (described above) with concrete
- Filling of the sinkhole with porous material specifically chosen to avoid settlement and to match hydrogeological characteristics of surrounding soils
- In parallel, one of the buildings was braced with a temporary steel structure

Ten days after the accident, the sinkhole had been filled and the crisis phase was over. Three more months were required until the surface utilities and works were entirely rebuilt and all signs of the accident erased.

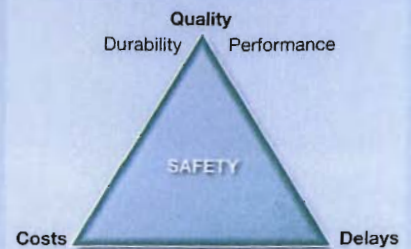
The diagram above illustrates the 'evaluation space for technical issues' as a triangle, bringing together the three key elements of project management. Meeting technical requirements (in terms of quality, performance and durability), controlling costs and respecting schedules cannot be dissociated. It is not enough to have one or the other.
